FLOOD PLAIN INFORMATION

FARMINGTON AND CONNECTICUT RIVERS

WINDSOR CONNECTICUT

PREPARED FOR
THE TOWN OF WINDSOR
BY
DEPARTMENT OF THE ARMY
NEW ENGLAND DIVISION, CORPS OF ENGINEERS
WALTHAM, MASSACHUSETTS
MARCH 1971

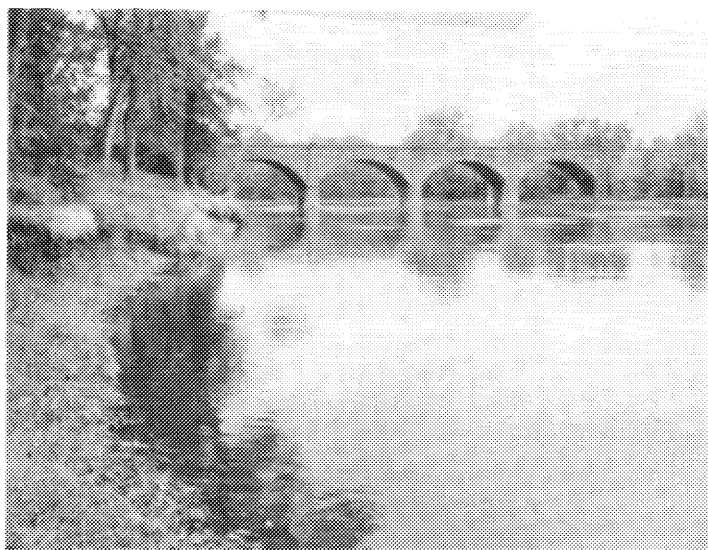
Palisado Avenue Bridge,
Farmington River , Windsor , Conn.
Looking downstream

Railroad Bridge
Farmington River, Windsor, Conn.
Looking upstream

The Palisado Avenue Bridge (Route 5A) and the railroad bridge just upstream on the Farmington River are the only bridges that will cause any obstructions to the flow of the river. This will be slight because of the wide flood plains over which the floods will flow.

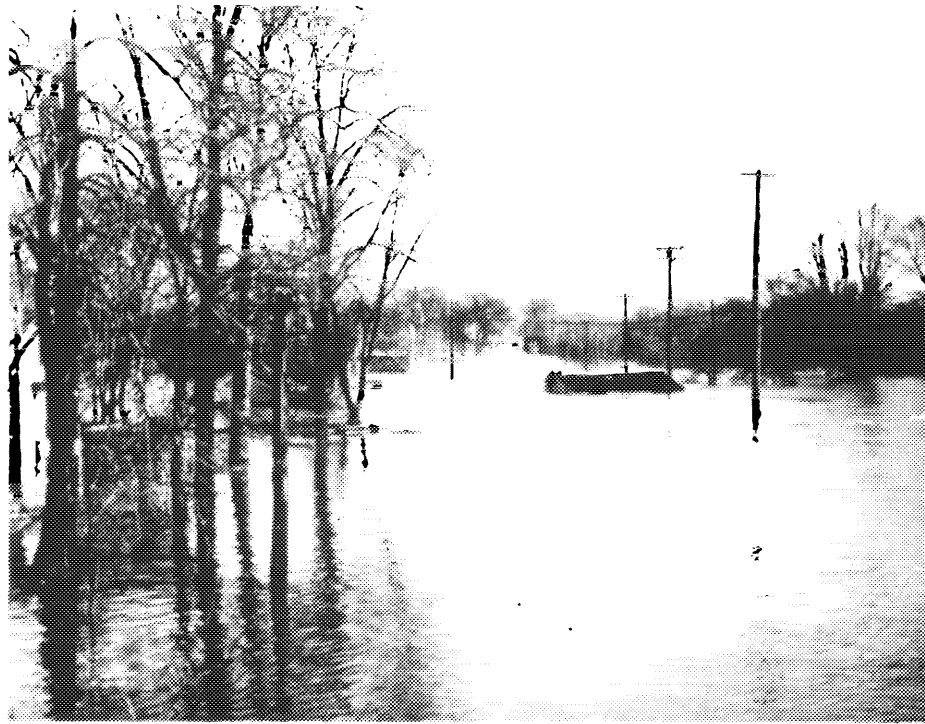
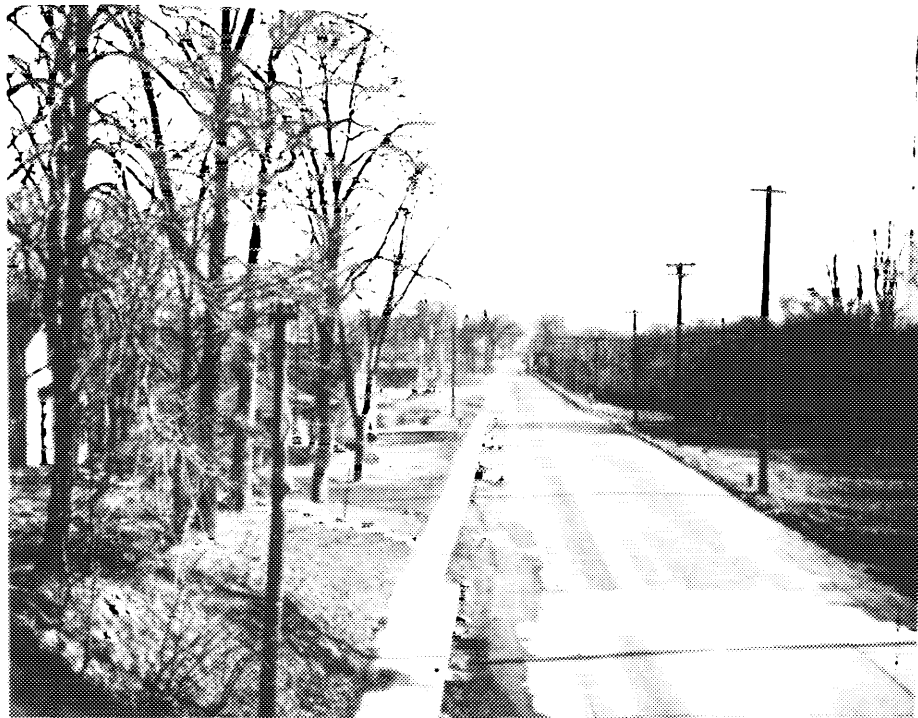
FIGURE 7

Palisado Avenue, Windsor, Conn.
The upper view is from Railroad Bridge,
looking towards Bridge over Farmington
River during March 1936 Flood.

Lower picture was taken from same
location, one year later.

General descriptions of large floods on the Farmington River are included with the discussion of past floods on the Connecticut River. Figure 7 shows a flood scene during the March 1936 flood from the railroad bridge over Palisado Avenue looking toward bridge over Farmington River and the lower picture was taken from the same location one year later. Figure 8 is a flood scene of the Farmington River taken in August 1955 about 1/2 mile downstream from Route 75 bridge in the village of Poquonock.
